<u>e Report</u>	Page1of1
Customer Name: Harris	•		02382
Contact Person: Ray Lor			AKE CHARLES
Contact Ph: (757) 342 39	960	Engine Hours:	
Work Location:	MANCHESTER TERMINAL		
Service Call Details	7 ENGINES WITH AN INSPECTION ON 3 OF THE	M	
Model: C280		Problem Type: INS	PECTIONS
Equipment: Generator		Call Type:	
Equip/Vessel:		Serial No.: O Port	NIK BUUT SU
9	Subject:		
CYLINDERS 15,13,11 A CYLINDERS. ALL THE L GOES FOR THE PISTO ROLLED OVER JUST FOR	E COVERS AND LOOKED AT ALL THE ROCKE AND 7. WE PULLED THE ROCKER ARMS AN INNERS STILL HAD THEIR CROSS HATCHING NS. OVERALL HEALTH OF THIS ENGINE IS GIVE. Sectures showing the cylinder liners, valves, cylinder liners is in good condition, all valves.	D THEN PULLED THE INJECTORS WITH NO SIGNS OF WASH OUT GREAT. ENGINE DOES NOT SEEM and piston heads, all showing to	OUT THEN SCOPED THE OR ANY OTHER DAMAGE. SAME TO HAVE ANY LEAKS AND IT o be in great condition. The

Service Report Page ME02382 Customer Name: Harris Companies Marine Job #: Contact Person: Ray Lorenzo Technician: **DRAKE CHARLES** Contact Ph: (757) 342-3960 **Engine Hours:** Work Location: MANCHESTER TERMINAL Service Call Details 7 ENGINES WITH AN INSPECTION ON 3 OF THEM Mode

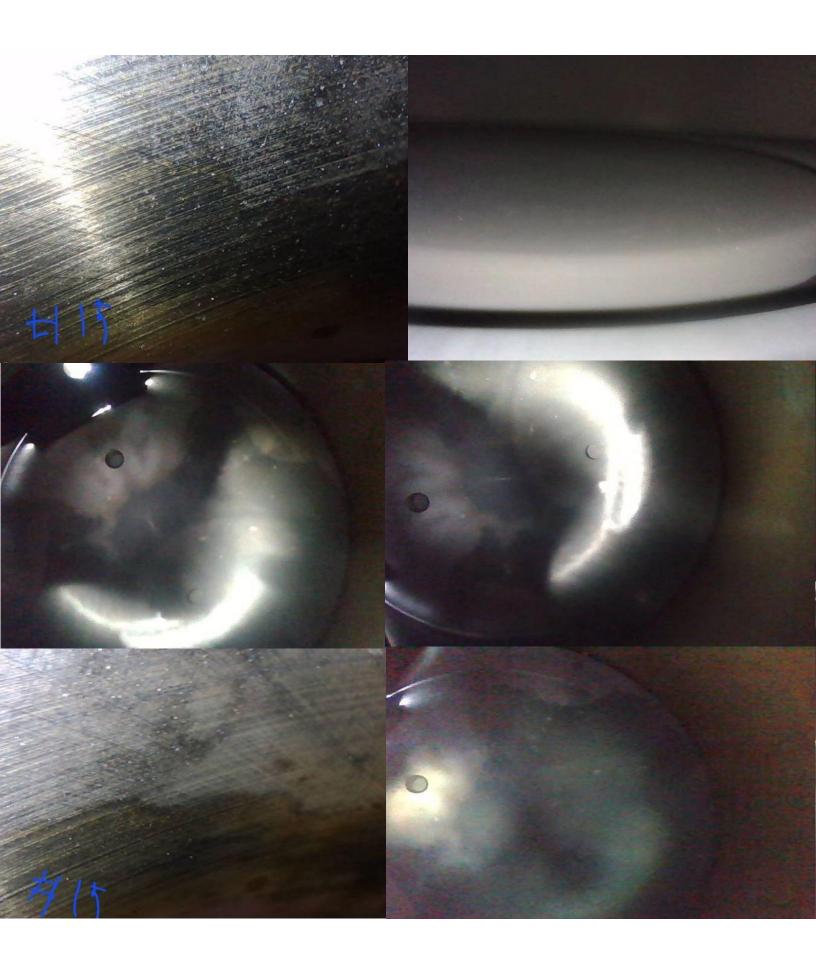
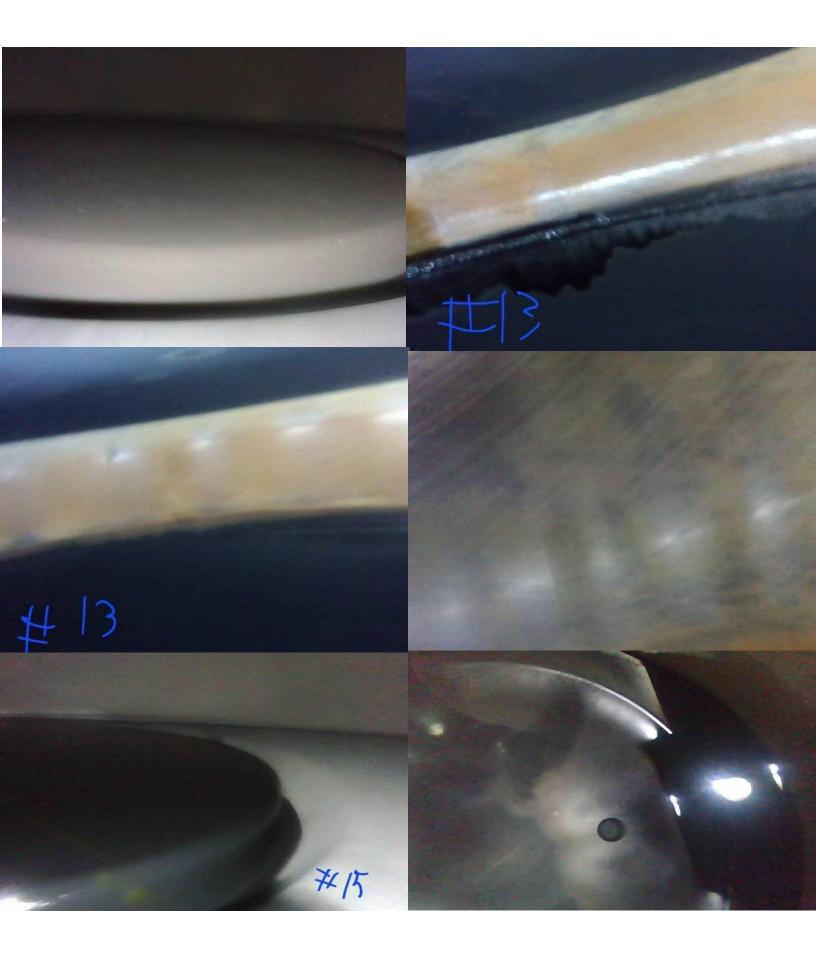
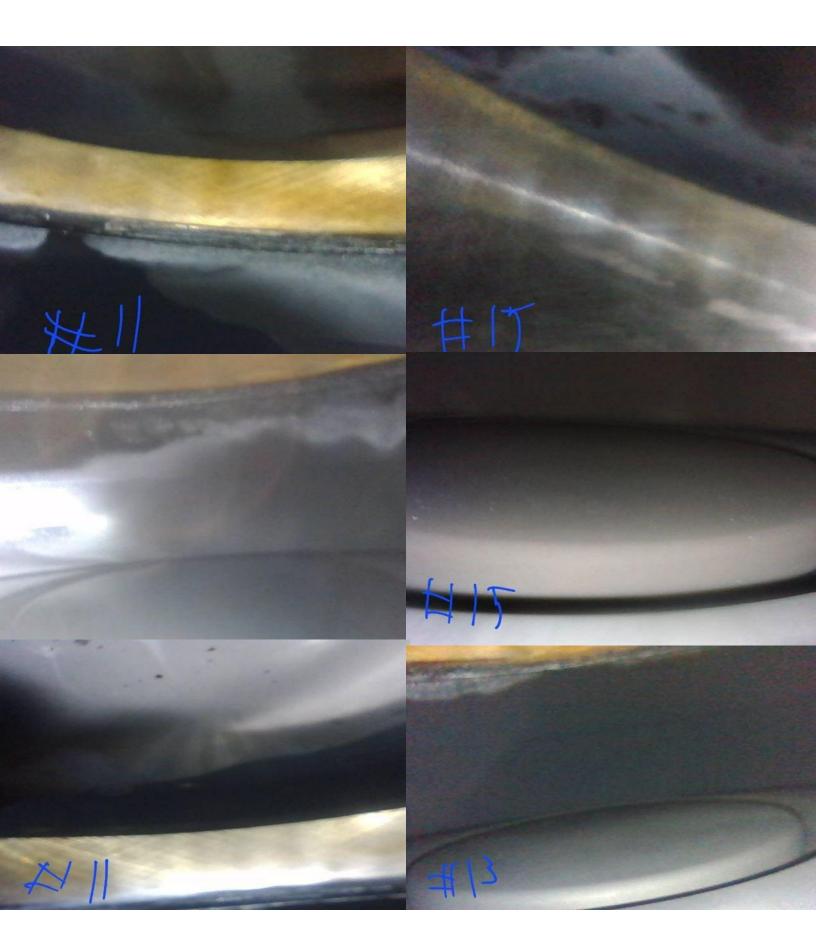
debris sitting on top of	of the pistons.		
		6/26/2023	Drake Charles
Authorized Customer Repres	sentative (Print)	Date	Technician

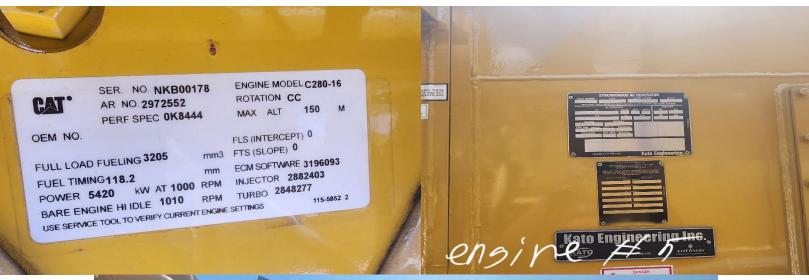
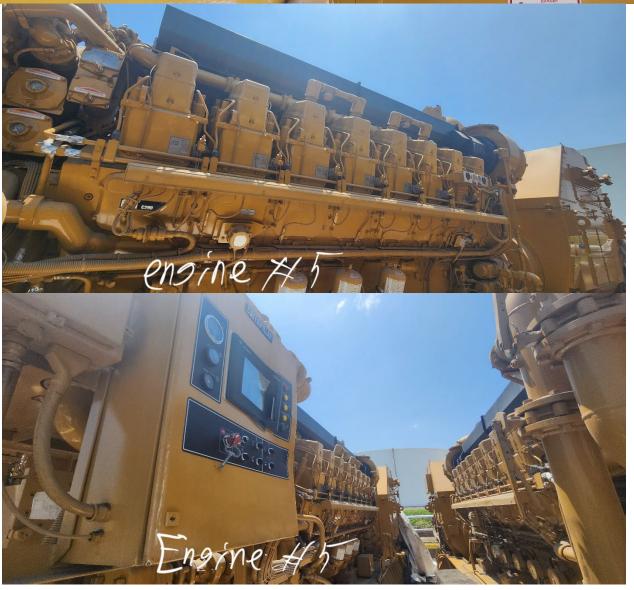
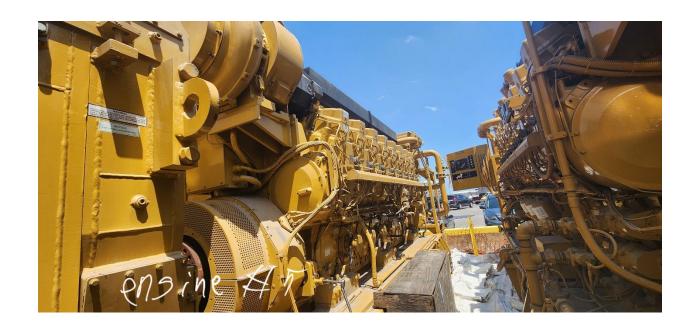
ROLLED THE ENGINE OVER AFTER CUTTING THE WRAPS OFF THE ENGINE. I ALSO DID A WALK AROUND AND CHECKED FOR ANY SIGNS OF LEAKS OR DAMAGE. NO SIGNS OF LEAKS WHILE DOING MY INSPECTIONS. EVERYTHING LOOKED TO BE IN GREAT CONDITION.
